Combined marine storm and Saros spring high tide erosion events along the KwaZulu-Natal coast in March 2007

A.M. Smith^{a*}, L.A. Guastella^a, S.C. Bundy^b and A.A. Mather^c

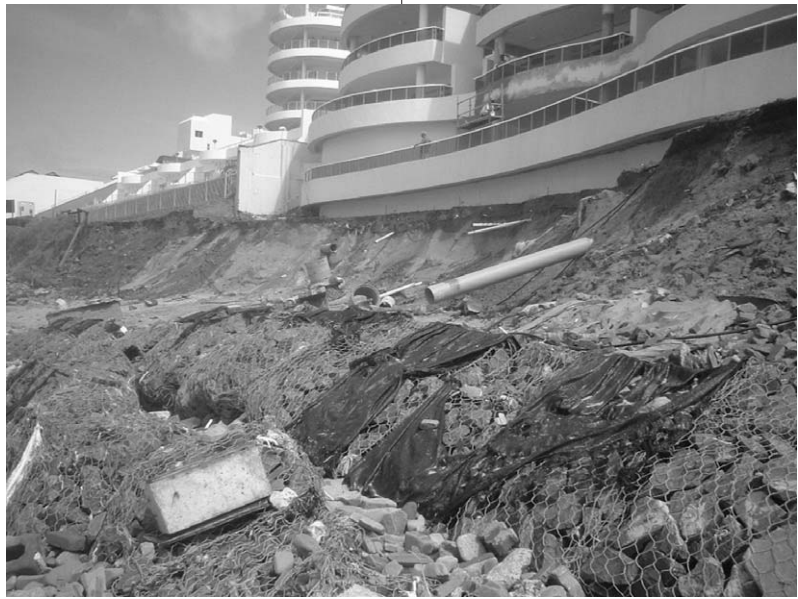
Fig. 2. Beach erosion at Ballito. Note the failed gabions of a previous sea-defence structure. The dune sand on which the structure stands has been undercut, exposing the infrastructure.

Storm swells erode sediment, lowering the beach profile,⁷ and this process led to coastal erosion. Property was damaged in heavily urbanized coastal areas, especially where development was close to the high water mark (HWM) (Fig. 2). The erosion line for this storm is located between the 4- and 5-m contours above mean sea level (between 4.9 and 5.9 m CD).

Coastal modification. Well-constructed seawalls stood in many instances. However, hydraulic roughness at their margins and crest (when they were overtopped by the sea) led to standing-wave erosion behind the walls. In extreme cases, this left the seawall standing while the sediment behind was removed. At other points, scour pits were excavated at the down-current end of standing seawalls. In some cases, waterloft walls

Property damage was accentuated in places where land had been reclaimed from the sea. In some instances, especially at Ballito, this was exacerbated where reclaimed land was built up. High banks failed when their toes were undercut by erosion. Coastal dune erosion had been noted in Ballito (at Salmon Bay) some six months earlier. The local authority relocated sand from the beach to bolster the dune to protect infrastructure. On 19–20 March, the most severe damage to built structures was near the area from which beach sand had been removed for this purpose.

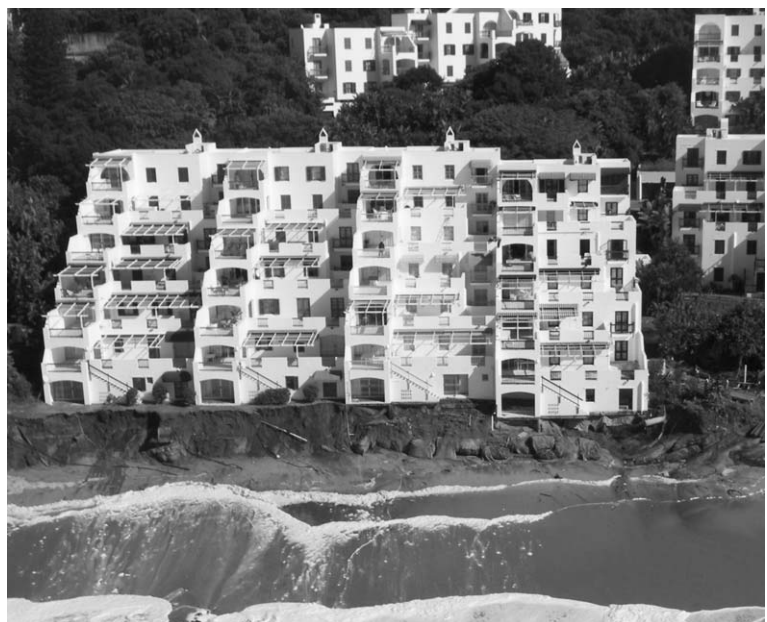
Fig. 3. A multi-storey building in Ballito, which was partially undercut by the storm.

The eThekweni (Durban) coastline lost an estimated 3.5 million cubic metres (5.2 million tons) of sand as a result of storm erosion. During the storm, the HWM retreated by 10–30 m in a few hours at Ballito (Fig. 3). Umkomaas, where the HWM retreated by 10 m, and Umdloti (16 m) also experienced severe marine

Coastal profile. Most of the KZN coast is relatively steep, which mitigated the damage. Ballito has one of the lowest coastal profiles in the province (between 0 and 15 m a.m.s.l.), however, and was the worst affected. At the town, and also in parts of Uvongo and of Scottburgh, the

erosion line cut through urban development and maximized the damage. Elsewhere this storm erosion line was located on the beach.
