REPORT ON THE MARCH 2007 COASTAL EROSION EVENT
FOR THE KWAZULU-NATAL MINISTER OF AGRICULTURAL
AND ENVIRONMENTAL AFFAIRS.

1. BACKGROUND

2. THE STORM OF 19-20 MARCH 2007

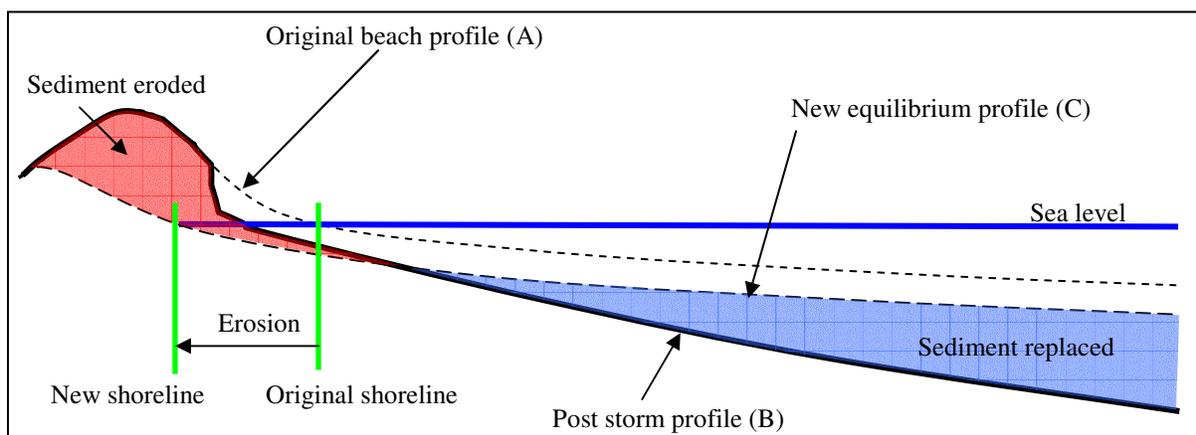
The original beach profile (A) erodes to the post storm profile (B) during the event. In a sand starved environment, the near shore receives very little returning sand from deeper water and now has to rely on the accumulation of sediment normally built up along the shoreline in the form of coastal dunes (shown red). The sea moves this sediment into the near shore zone (shown blue) so that the seabed profile (C) is returned to the same slope as the original beach profile (A).

Figure 2: Beach response to storm events and the re-establishment of the equilibrium profile.

The storm was significant enough to change the seabed profile and to remove all the previously positioned sand bars, which normally help reduce the wave energy arriving at the coast. Seabed changes in deep water were recorded in Richard's Bay where the existing dumpsite mound was eroded from -11m to -17m and the sediment distributed in a southeasterly direction to a depth of -22m (Ramsay Pers. Comm. 2007). These waves were energetic enough to move sediment offshore to a position where it is unlikely to return completely to the near shore and beach area. This combination resulted in a sand starved coastline with no protection stretching from St Lucia in the north to beyond Margate in the south. This situation resulted in a beach profile, which is out of its normal equilibrium and results in the sea attempting to readjust to its normal equilibrium profile (Figure 2).

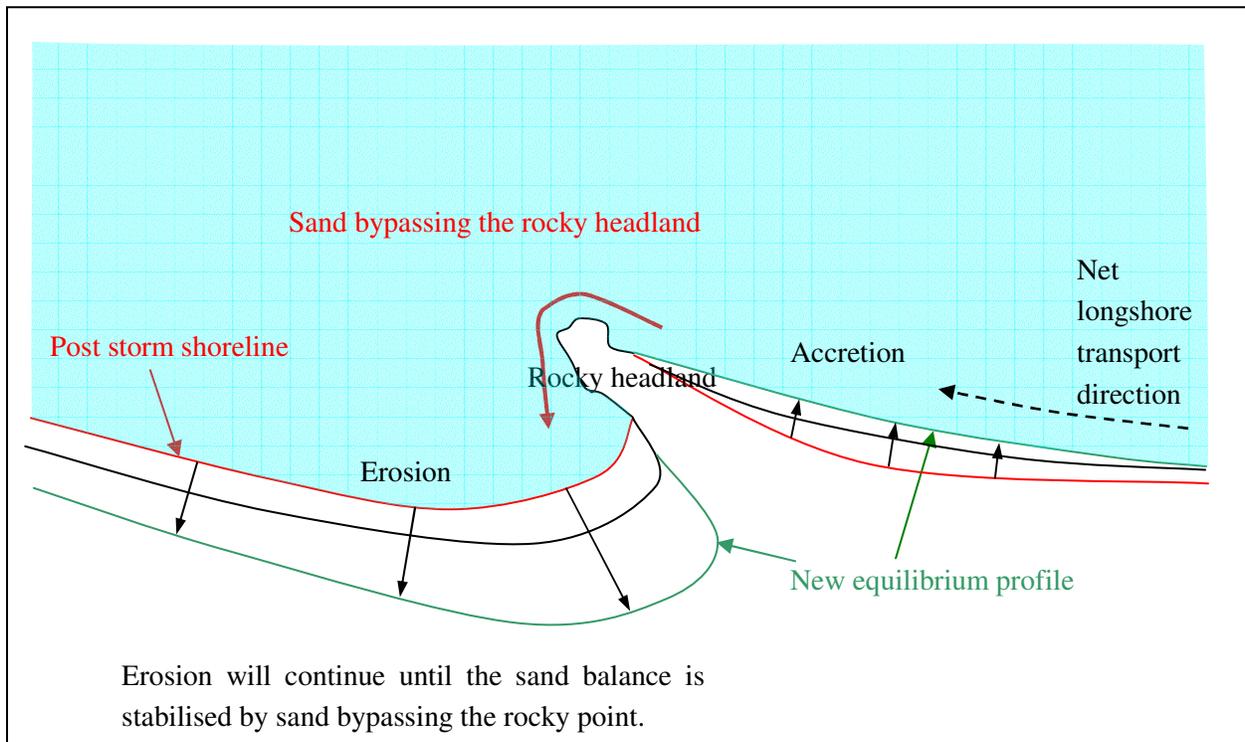
The erosion at Amanzimtoti was caused by the system attempting to get back into equilibrium. Normally the sediment bypassing the rocky headlands feeds the up drift beach keeping the equilibrium. As the winter storms started coming through from the south the sand started moving northward. However as the sand was lost across all beaches there was no available sand to feed the beaches north of the rocky headland, resulting in beaches accreting to the south and eroding to the north of headlands (figure 3). This cycle is repeated in each bay and explains why Amanzimtoti and Happy Wonders suffer extensive erosion. Amanzimtoti recorded over 90m of erosion in the space of two weeks.

Figure 3: Sand bypass around a headland

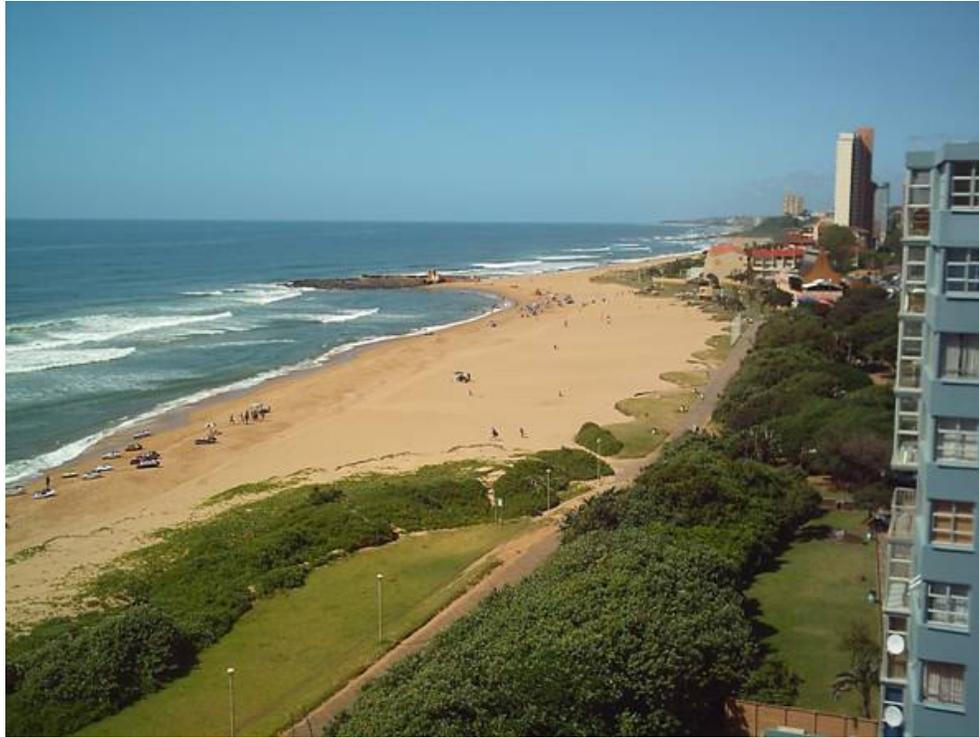
This can be seen in the pictures of Amanzimtoti beach over the period prior to the March event (Figure 4a) and the current situation (Figure 4b).

Figure 4a: Amanzimtoti beach in January 2007

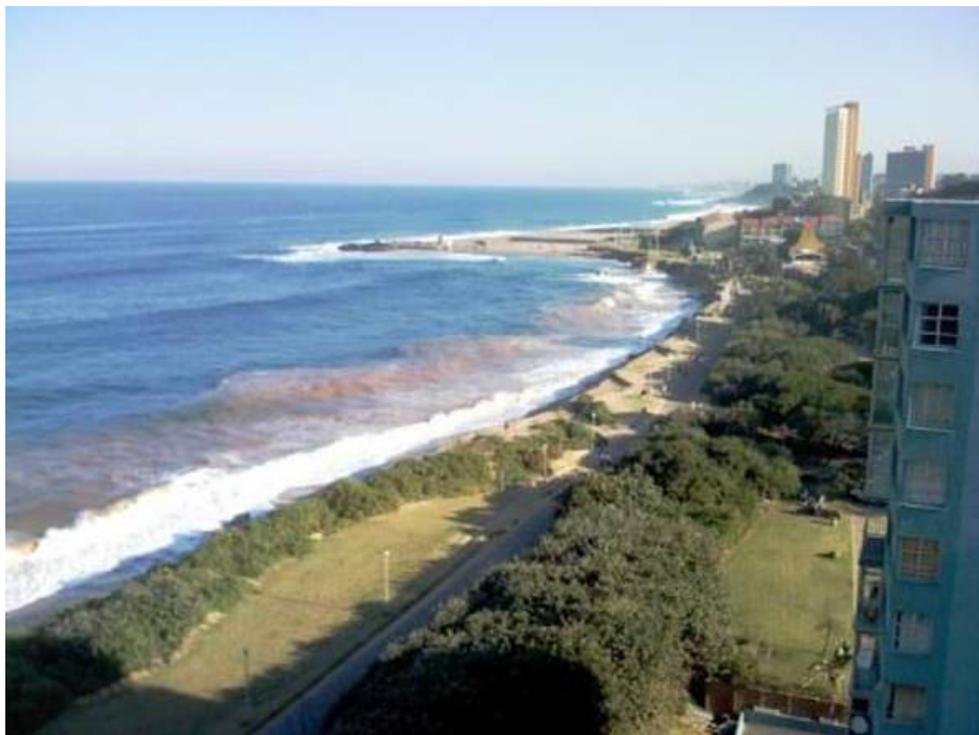
Figure 4b: Amanzimtoti beach in July 2007

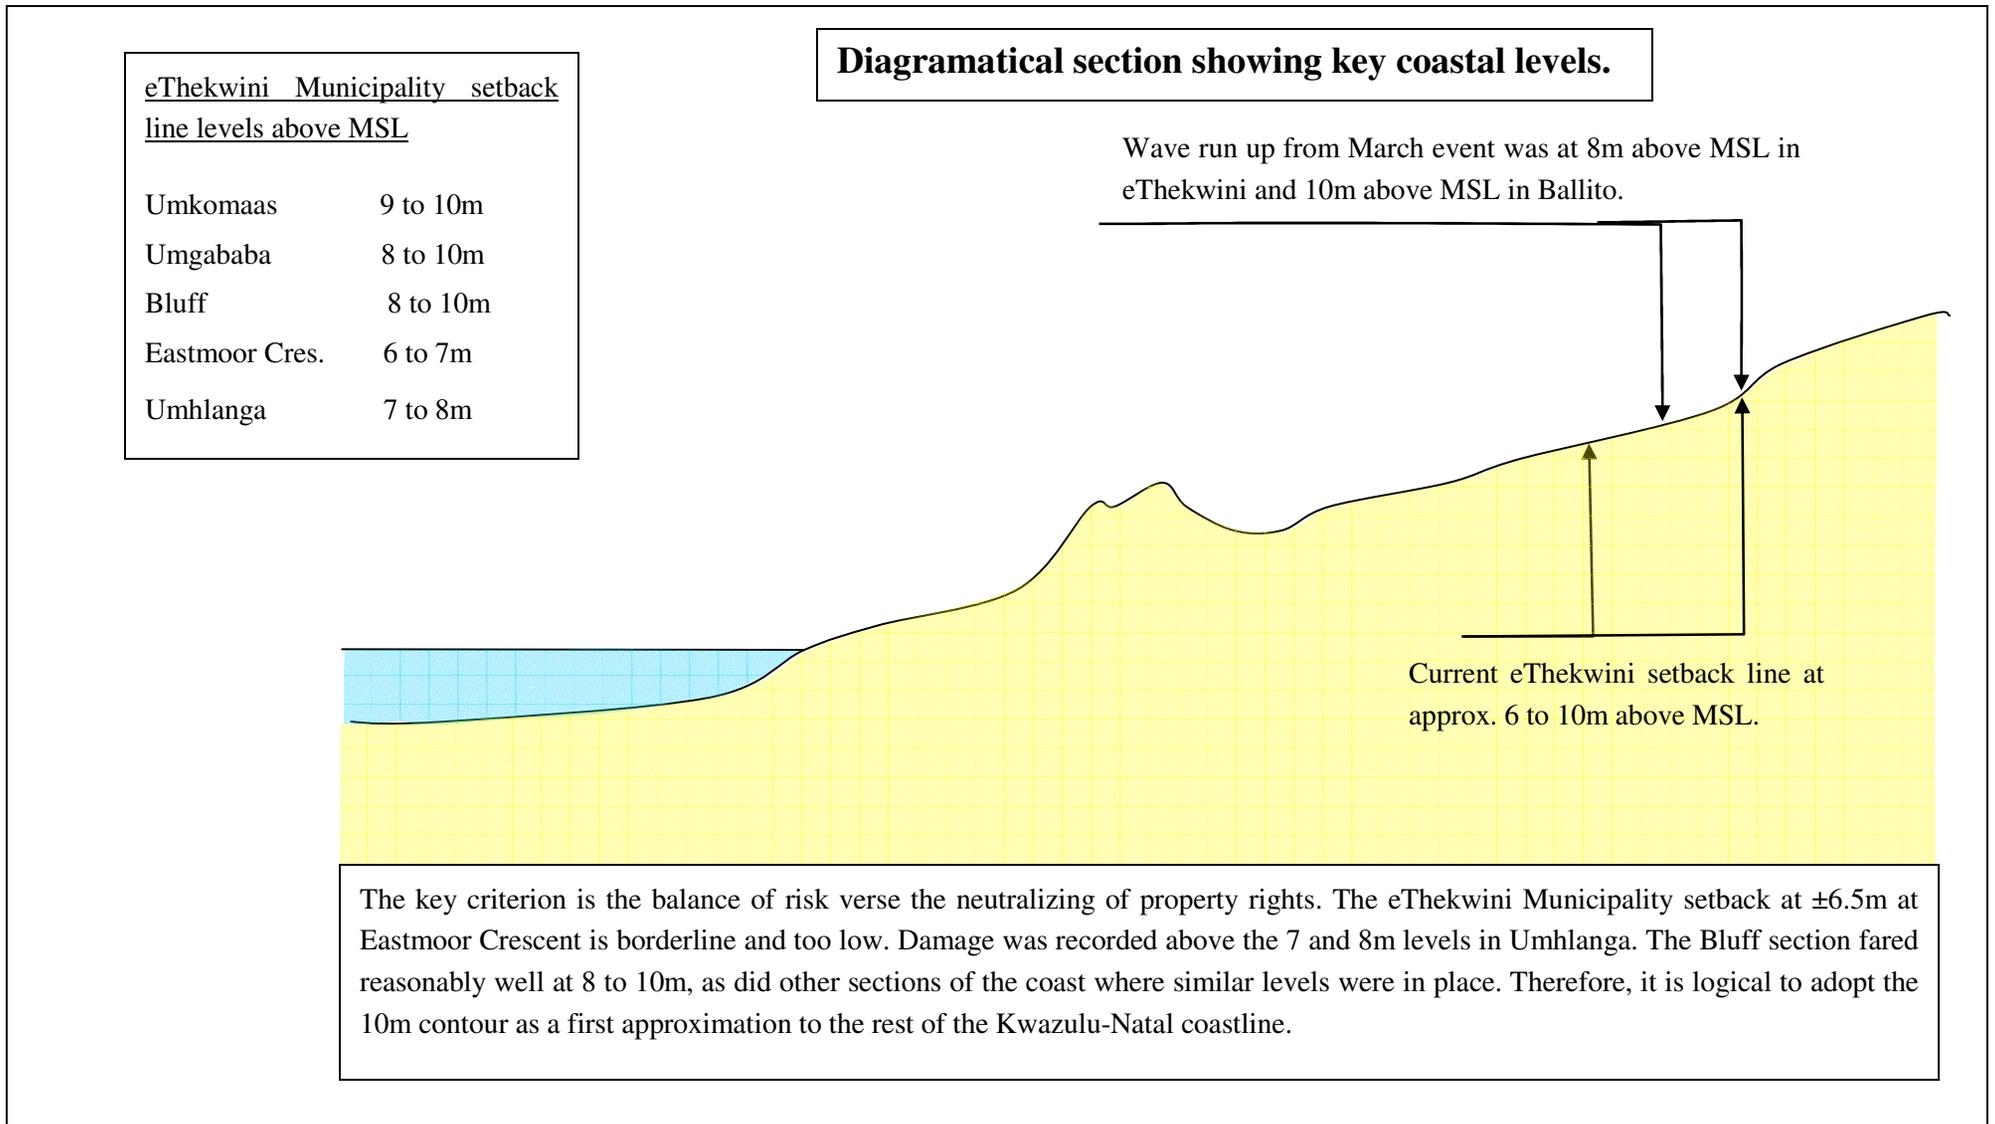
Figure 5: Diagrammatic layout of proposed initial setback lines for KZN.

- ii. The implementation of development set back lines based on a long-term view of the coastline. For example to formulate development setback lines based on a 1:100 year storm combined with projected sea level rise to 2100. eThekweni Municipality has this in place by based on a 1:50 year storm and 50 years of sea level rise and this has been shown to have been exceeded in a number of location along our coast during this storm and the sea’s subsequent readjustments to the shoreline. This set back line is not in place for the whole coastline at present and with the impacts of the storm on the eThekweni Municipality coastline, it is clear that a more conservative line is established for the KZN coastline. Based on our own work it is recommended that the KZN development setback line be set at a contour level of 10m above MSL (see Figure 5).
