SUB-SLAB, SOIL, SURFACE WATER AND GROUNDWATER ASPECTS RELATING TO THE UPL WAREHOUSE FIRE - CORNUBIA

9TH OCTOBER 2023

SUB-SLAB TEST PIT REPORT

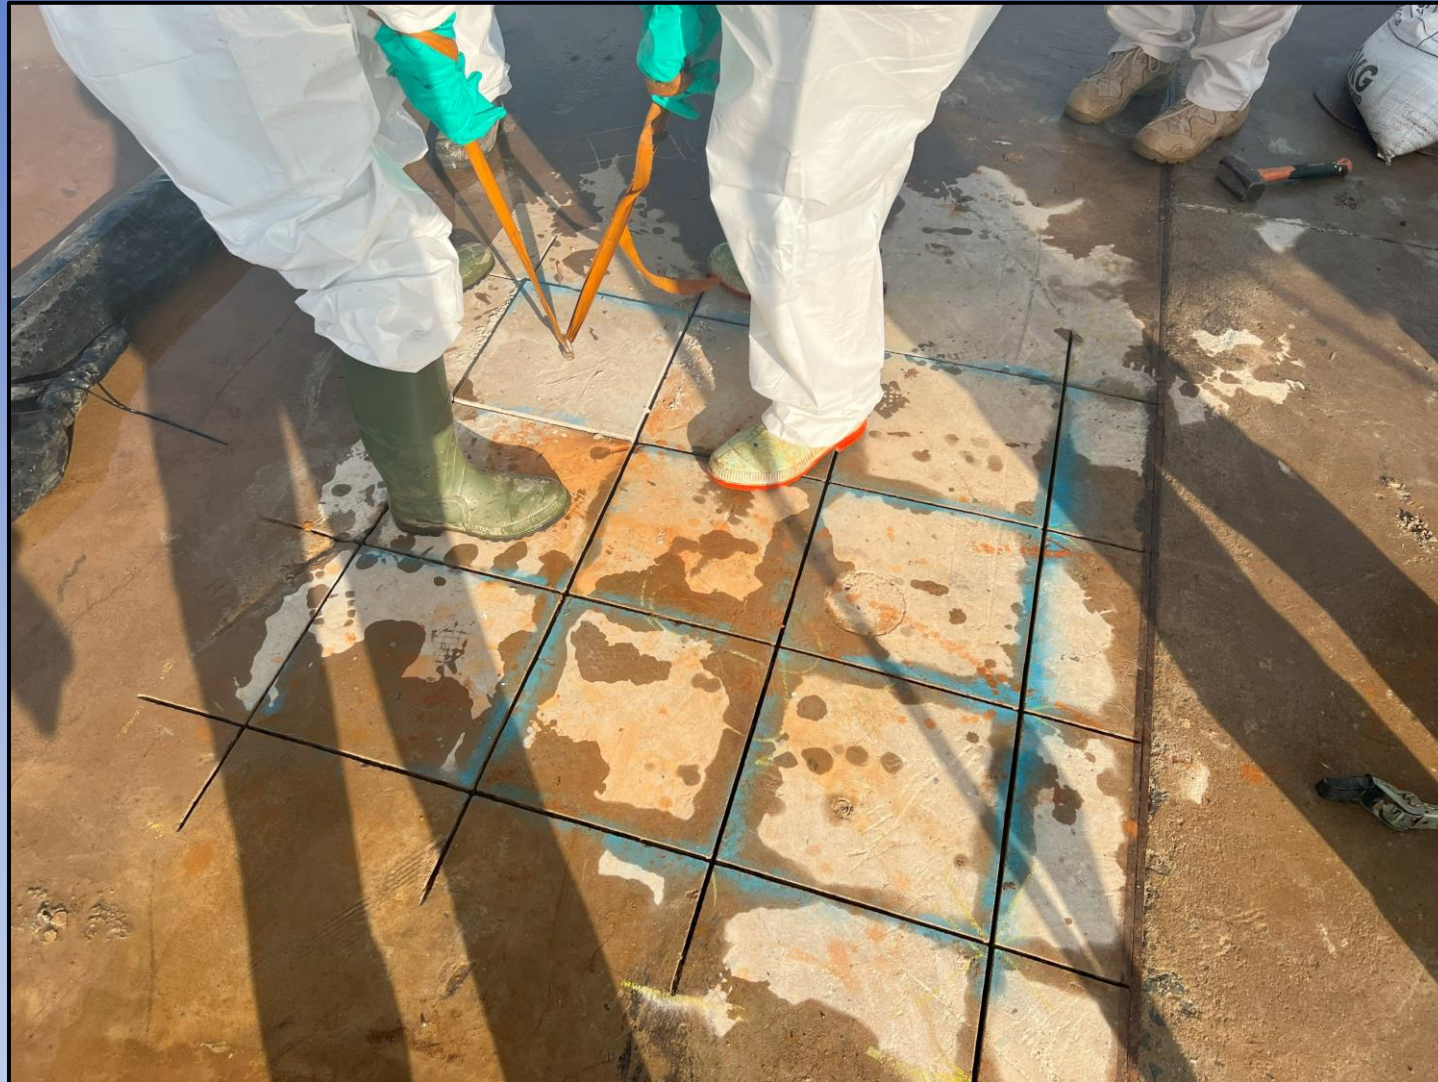
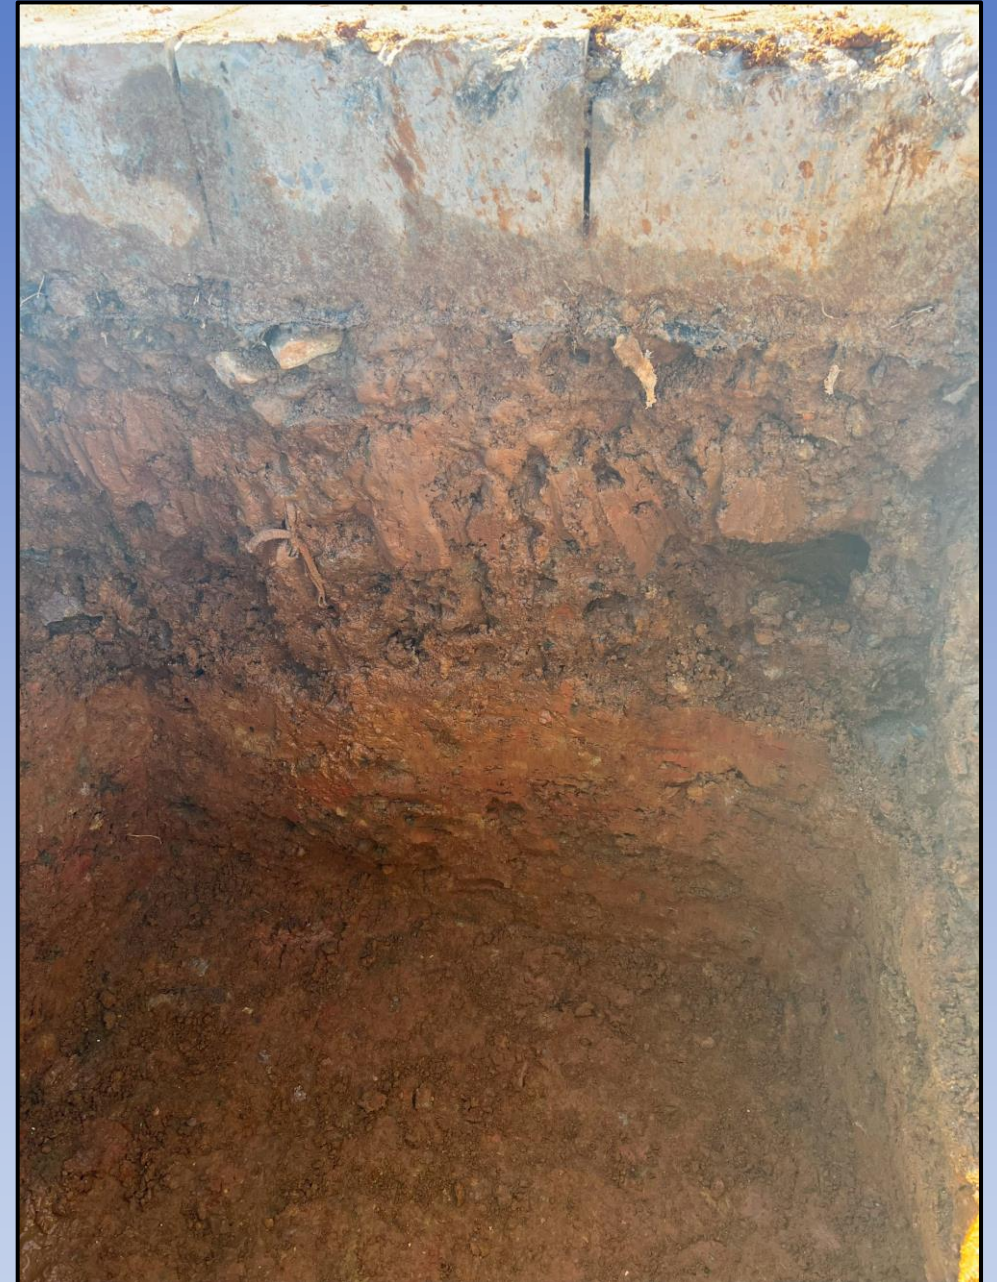
SUB-SLAB TEST PIT SAMPLING EXCAVATION OF TEST PITS

- Purpose of the sampling is to visually observe what is beneath the slab, to bulk sample hot spot areas and to conduct geotechnical tests.
- Two (2) test pits were excavated and geologically logged and the fill layers including the G5, G7 and bulk fill were sampled.
- The G5, G7 and bulk fill remains impacted in these two (2) test pits.
- Pools of perched water (mixture of contaminants and fire fighting water) still remain beneath the slab.
- The review of fill sample results indicate that the samples meets the requirements of the
 - composite worker RBSLs
 - indoor worker RBSLs,
 - residential soils RBSLs and the
 - commercial / industrial screening levels.
- The geotechnical tests have shown that the fill material is not very permeable.

- Completion of the geohydrological report.
- Sub-slab perimeter and drain sampling to commence.
- Microbial trials are proposed to be conducted in TP 2 excavated during the sub-slab test pit sampling.
- October 2023 routine monthly sampling report completion.
- November and December 2023 routine monthly sampling to be conducted.
