# Durban Nurdle Spill, 2017

Capt. Julke Brandt, Technical Adviser

15<sup>th</sup> February 2021

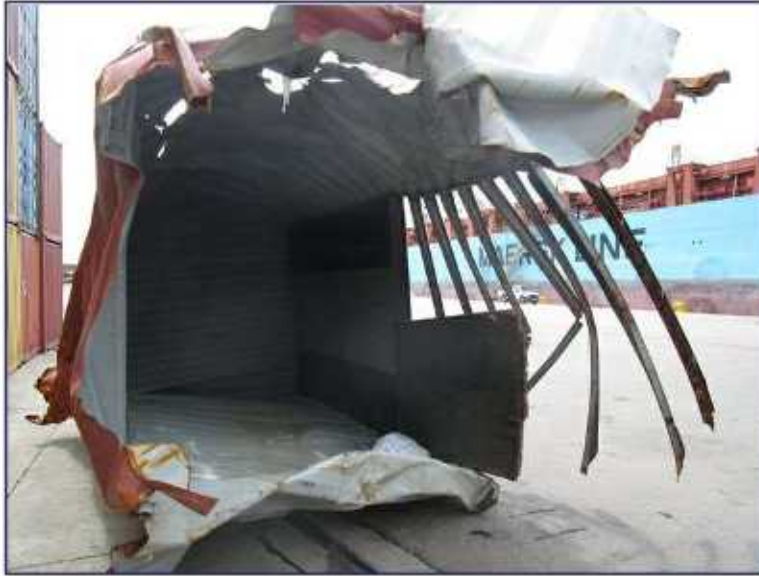
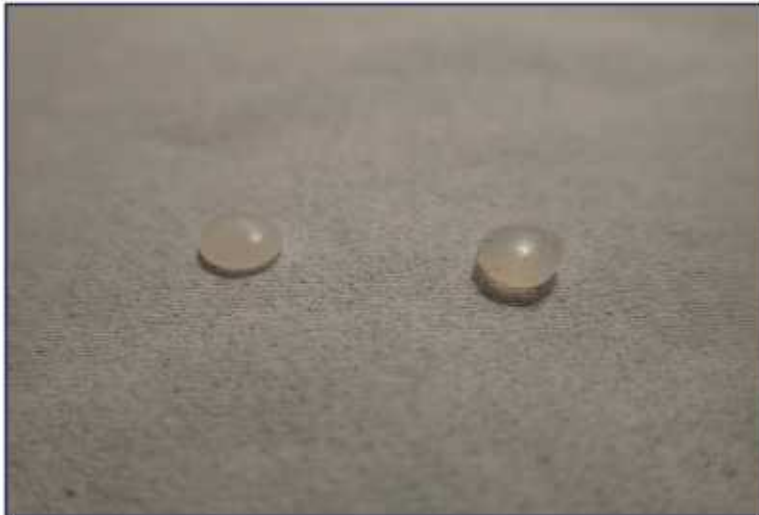
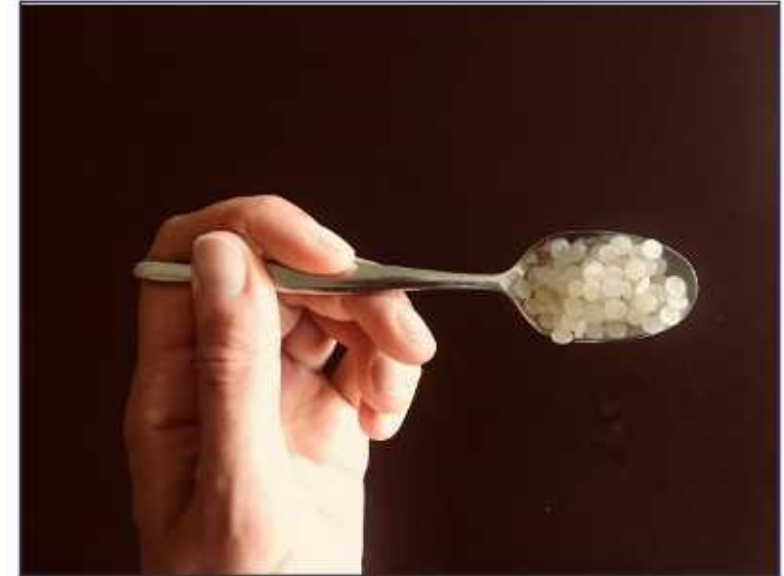
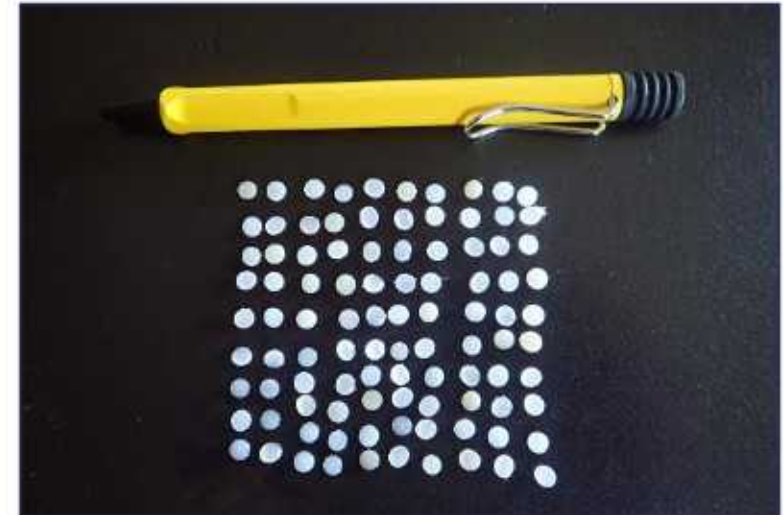
## High & Low Density Polyethylene

- Diameter: 5 mm
- Density: 0.91-0.97 g/cm<sup>3</sup> → float
- Transported in 25 kg bags, shrink wrapped onto pallet bases
- Are not considered hazardous as per
  - OSHA Hazard Communication Standard
  - IMDG Code
- But they might be ingested by animals, can adsorb persistent organic pollutants, do not biodegrade
