## UPL Media Response 1

### Questions from Tony Carnie

11 May 2022

#### QUESTIONS IN RELATION TO DIOXINS AND FURANS

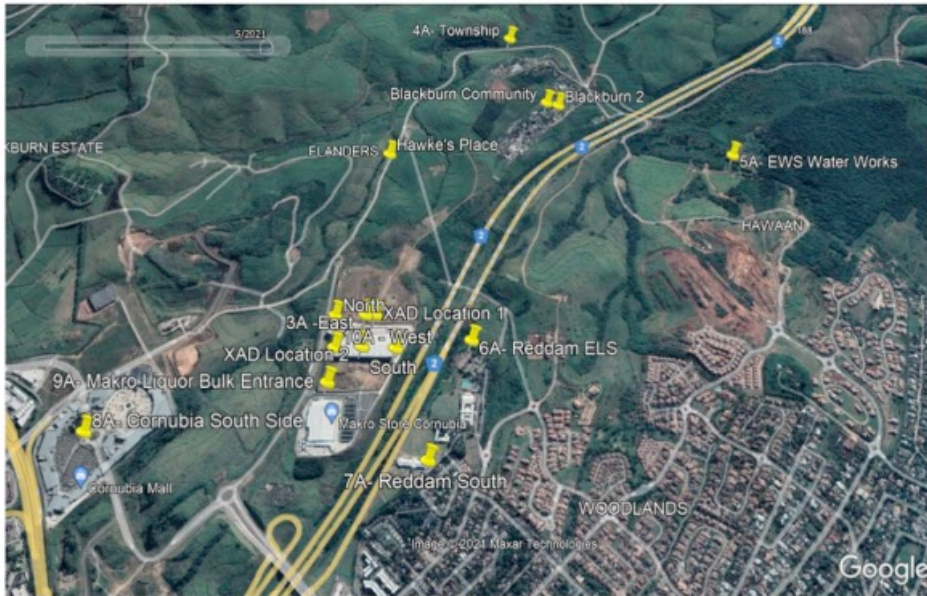
Figure 1: Map of sampling locations at Cornubia and surrounding areas

See below table and map of locations.

Table 1: Sample Location descriptors

SITE DESCRIPTION	LATITUDE	LONGITUDE
North	29°42'23.48"S	31° 3'47.45"E
South	29°42'27.95"S	31° 3'57.45"E
East	29°42'23.26"S	31° 3'52.13"E
West	29°42'28.20"S	31° 3'48.28"E
Cornubia South Side	29°42'41.74"S	31° 3'15.68"E
4A- Township	29°41'30.97"S	31° 4'10.42"E
5A- EWS Water Works	29°41'51.94"S	31° 4'50.63"E
Makro Liquor Bulk Entrance/Entrance (South)	29°42'33.17"S	31° 3'48.23"E
Reddam ELS	29°42'25.91"S	31° 4'8.54"E
7A- Reddam South	29°42'42.30"S	31° 4'4.06"E
Blackburn Community	29°41'44.00"S	31° 4'18.00"E
Location 1 (East Fenceline)	29°42'23.23"S	31° 3'53.63"E
Location 2 (Between South and West Fenceline)	29°42'28.03"S	31° 3'52.42"E
Blackburn 2	29° 41' 44.34"S	31° 4' 20.064"E
Hawke's Place	29° 41' 55.96"S	31° 3' 51.55"E
Ottawa South	29° 40' 44.02"S	31° 3' 24.67"E
Minor Catchment	29° 42' 4.56"S	31° 3' 16.81"E
Mt Edgcombe Driving Range	29° 43' 9.75"S	31° 2' 33.39"E
Portland Drive	29° 42' 57.43"S	31° 5' 18.61"E
Cornubia Island 2	29°42'36.15"S	31° 3'20.20"E
